Annual Inspection

Sturmer Parish Council

Pocket Park

Water Lane, Sturmer, Essex, CB9 7XF

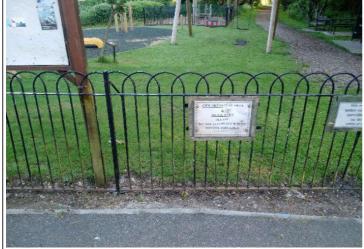
Item: Signs - Playground Sign

Finding: It is recommended that signage, with information including the site address, contact information for maintenance issues and emergency contact details are provided for the facility

Action: Provide in accordance with the recommendations

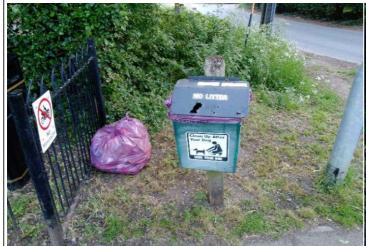
Item: Ancillary Items - Dog Litter Bin

Parts of the steel on this item have corroded excessively and the metal has perforated in places - Ensure all affected areas are treated and repaired

Finding: Parts of the steel on this item have corroded excessively and the metal has perforated in places

Action: Ensure all affected areas are treated and repaired

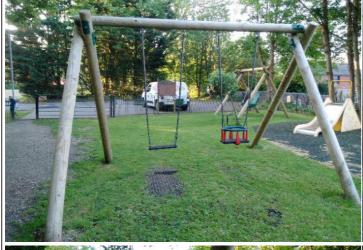
Item: Swings - 1 Bay Mixed Seat, 1 Cradle, 1 Risk Level: L - Low Risk

The timber has a number of splits/shakes or air cracks and this may affect the stability or allow water ingress which will accelerate the rotting process - Monitor to ensure the splits do not cross through fixing points of the structure and/or cause any instability

Finding: The timber has a number of splits/shakes or air **Action:** Monitor to ensure the splits do not cross through cracks and this may affect the stability or allow water ingress fixing points of the structure and/or cause any instability which will accelerate the rotting process

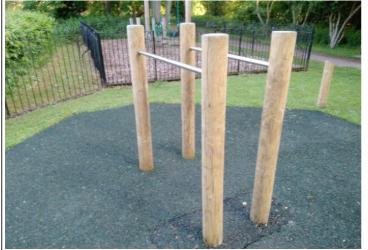
Item: Activity Equipment - Parallel Bars

Finding: There is no identification label affixed to the equipment

Action: Provide an identification label

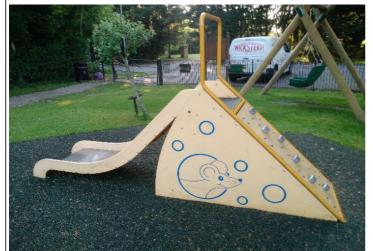
Item: Other - Slide Unit
Manufacturer: Unknown

Finding: There is no identification label affixed to the equipment

Action: Provide an identification label

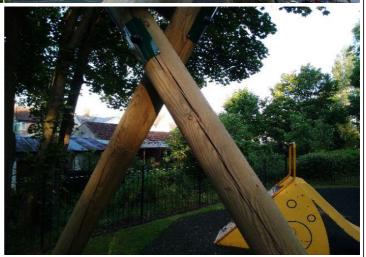
Item:Swings - 1 Bay SwingRisk Level:L - Low RiskManufacturer:UnknownSurface:Grass Matrix Tiles

The timber has a number of splits/shakes or air cracks and this may affect the stability or allow water ingress which will accelerate the rotting process - Monitor to ensure the splits do not cross through fixing points of the structure and/or cause any instability

Finding: The timber has a number of splits/shakes or air cracks and this may affect the stability or allow water ingress fixing points of the structure and/or cause any instability which will accelerate the rotting process

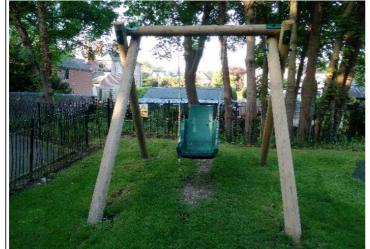
Item: Swings - 1 Bay Swing

Finding: There is no identification label affixed to the

equipment

Action: Provide an identification label

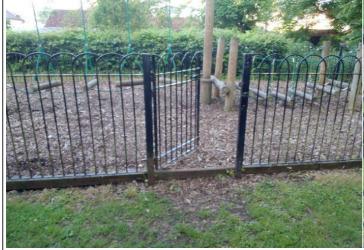
Item: Gates - Gate - Pedestrian

The gate is not operating correctly - Take effective action to ensure the gate closes between 4 and 8 seconds

Finding: The gate is not operating correctly

Action: Take effective action to ensure the gate closes between 4 and 8 seconds

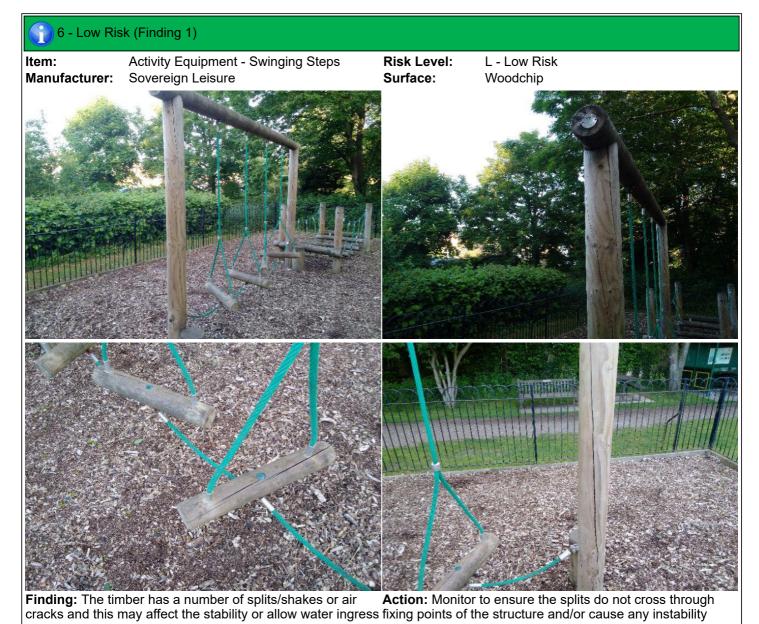
The timber has a number of splits/shakes or air cracks and this may affect the stability or allow water ingress which will accelerate the rotting process - Monitor to ensure the splits do not cross through fixing points of the structure and/or cause any instability

cracks and this may affect the stability or allow water ingress fixing points of the structure and/or cause any instability which will accelerate the rotting process

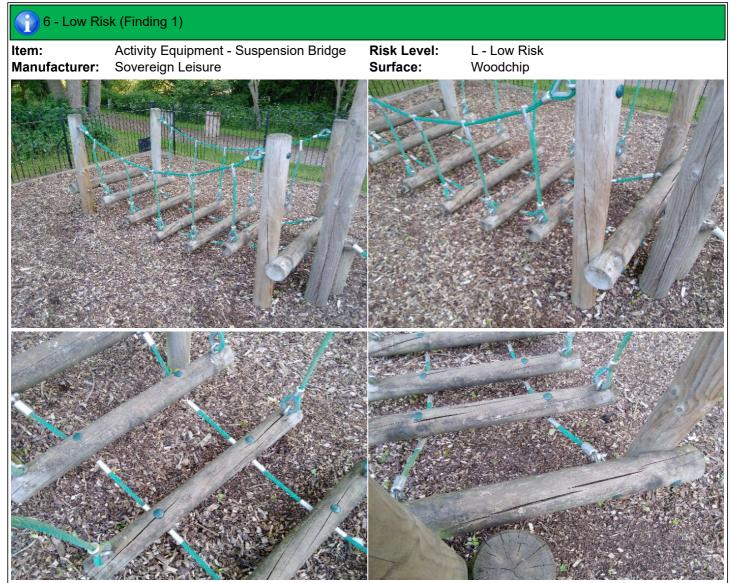
The timber has a number of splits/shakes or air cracks and this may affect the stability or allow water ingress which will accelerate the rotting process - Monitor to ensure the splits do not cross through fixing points of the structure and/or cause any instability

Finding: The timber has a number of splits/shakes or air Action: Monitor to ensure the splits do not cross through cracks and this may affect the stability or allow water ingress fixing points of the structure and/or cause any instability which will accelerate the rotting process
