Annual Inspection

Sturmer Parish Council

Pocket Park

Water Lane, Sturmer, Essex, CB9 7XF

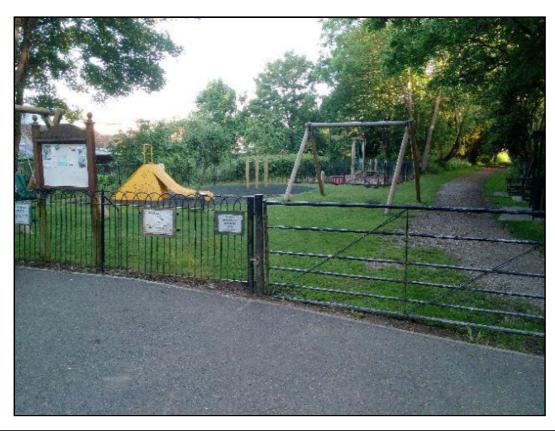
Inspected: 8-June-2021 - 05:07 by Chris Newell

Risk Assessment: 12 Moderate Risk

The site is located in an area of public open space and is not directly overlooked by any properties in the local community.
